ArmorThane®

ArmorBlast™ Coating Withstands Explosion

The University of Missouri, Rolla, tested ArmorThane's ArmorBlast coatings on a structure of concrete masonry units (CMU) to simulate public buildings. When explosives were detonated, the results surprised the UMR Explosives Laboratory.

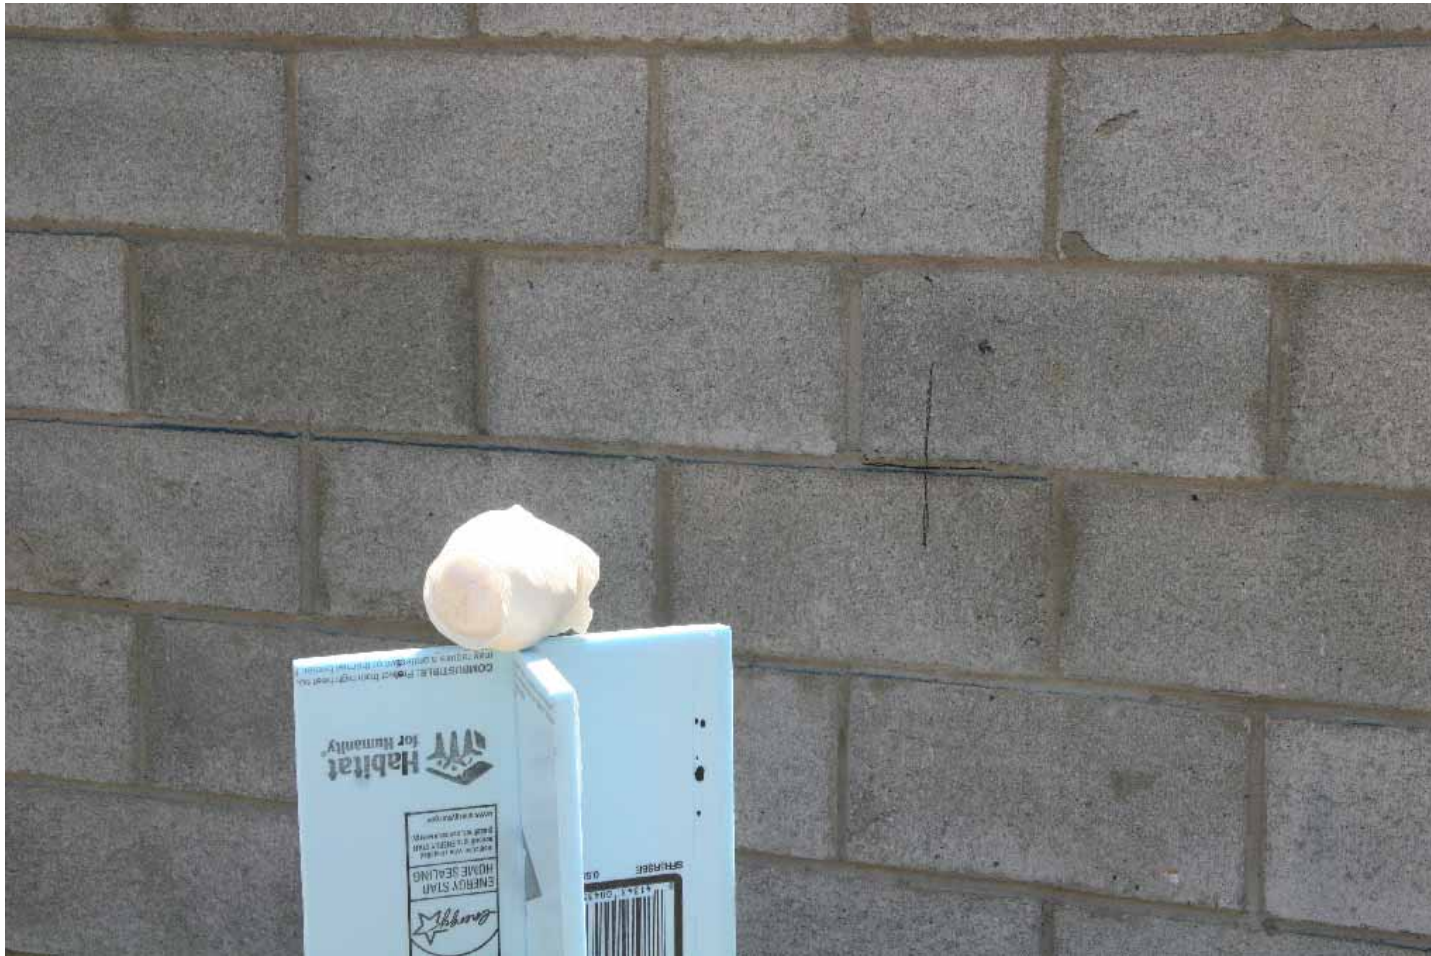
Uncoated Control Wall

Pre-Blast: Outside View @ 3ft

Each wall was prepared for a different test including an uncoated Control wall (North). Both video and digital still photography documented the events.

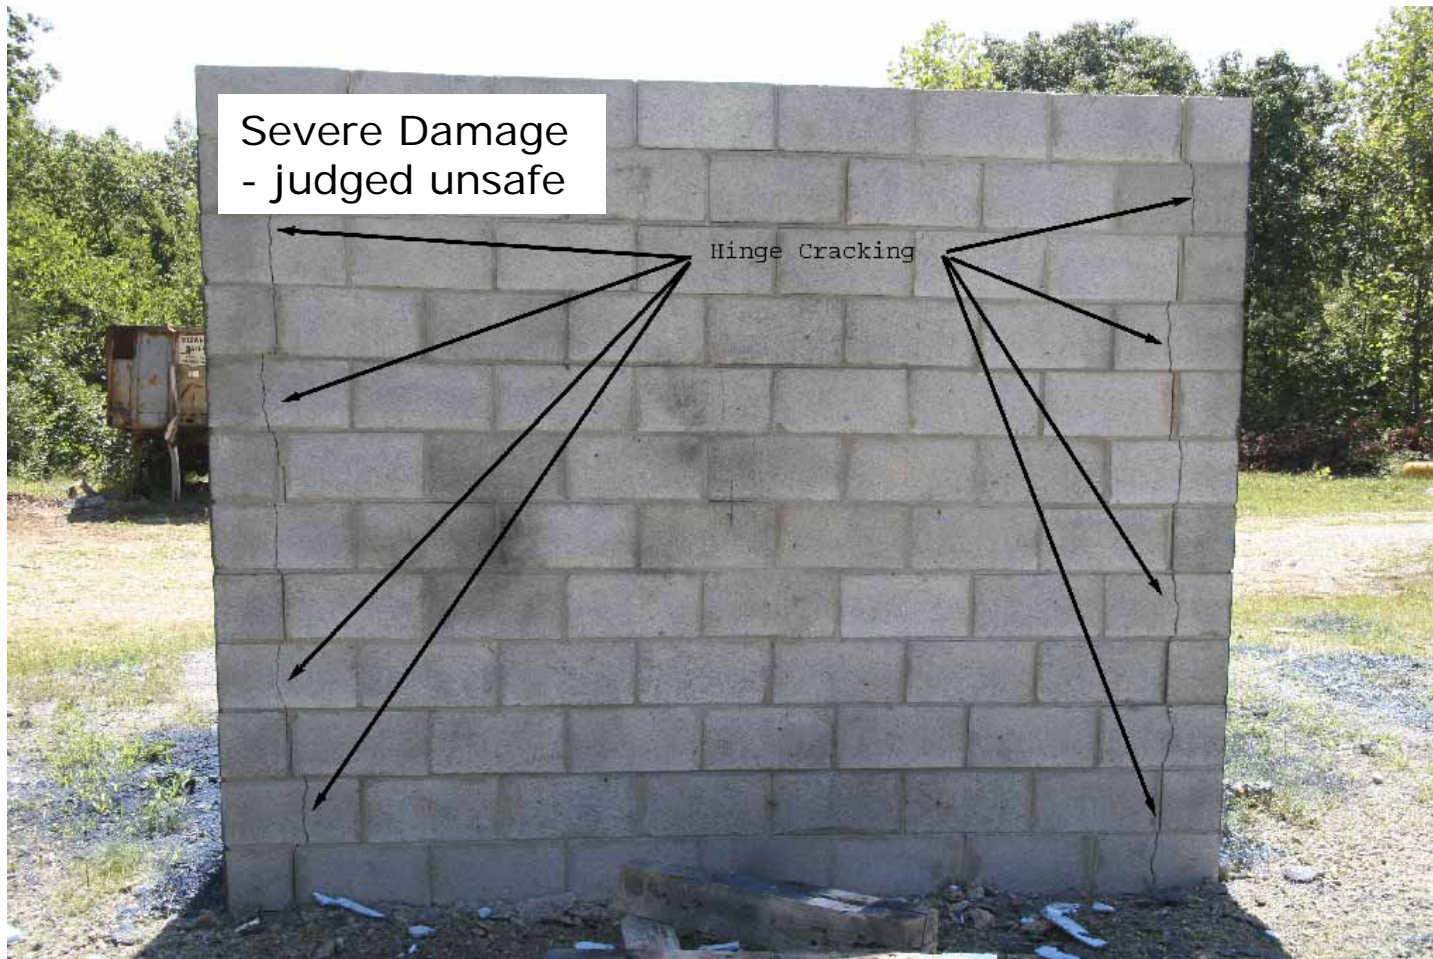
Uncoated Control Wall Post-Blast Results: Outside View

With the first two-pound charge, the Control wall (North) cracked vertically in the center of the back side opposite the charge position. Small cracks also formed randomly

on the front and vertical hinge cracks were found on either side where the uncoated wall attached to the other walls.

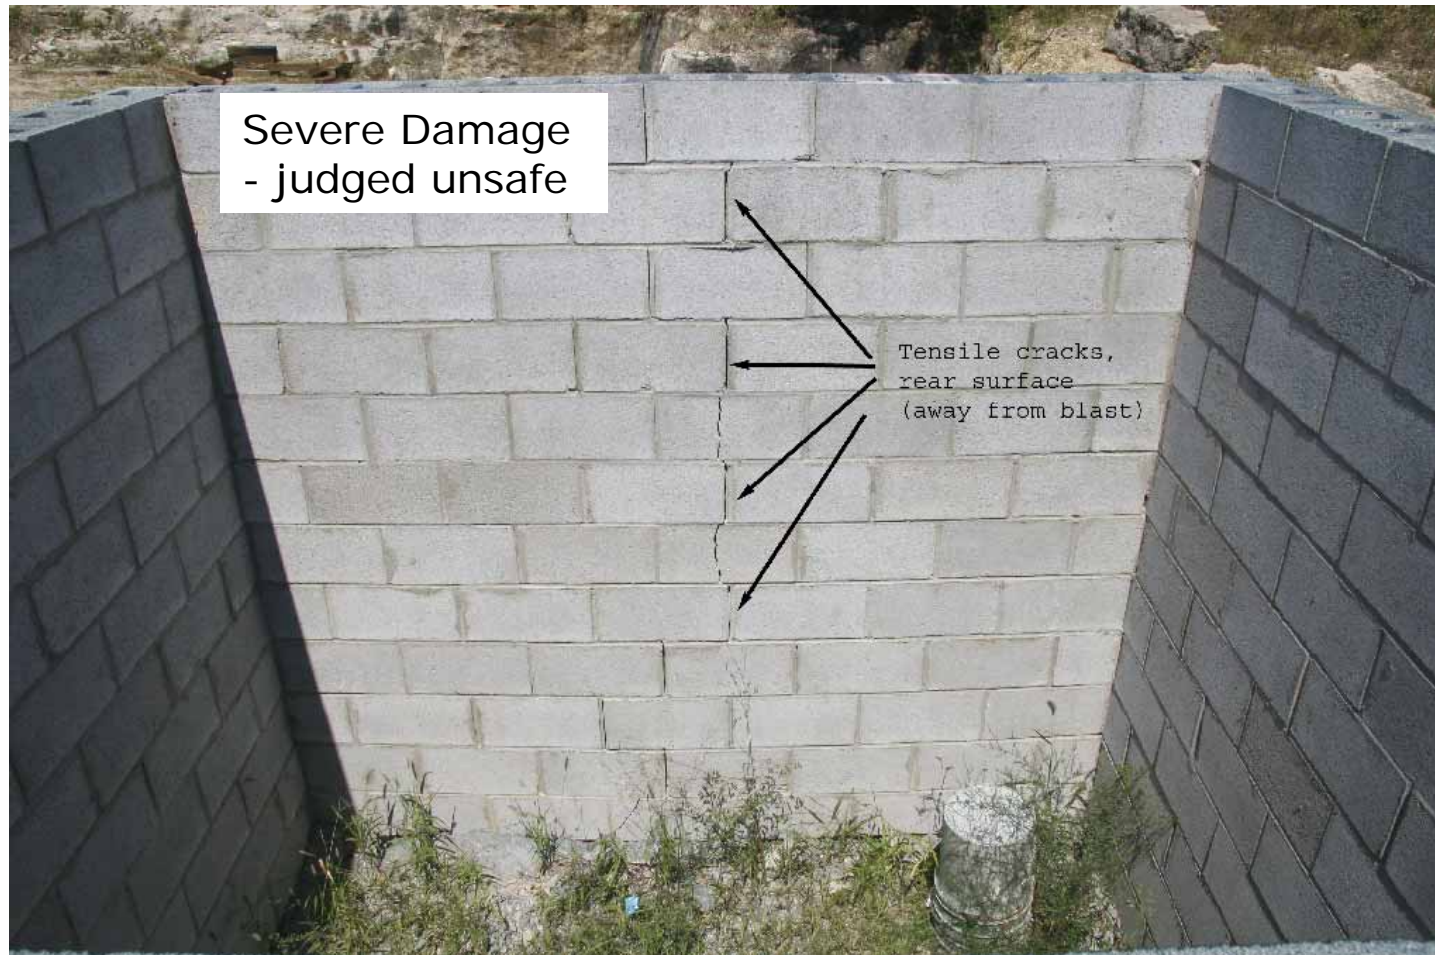
Uncoated Control Wall

Post-Blast Results: Inside View

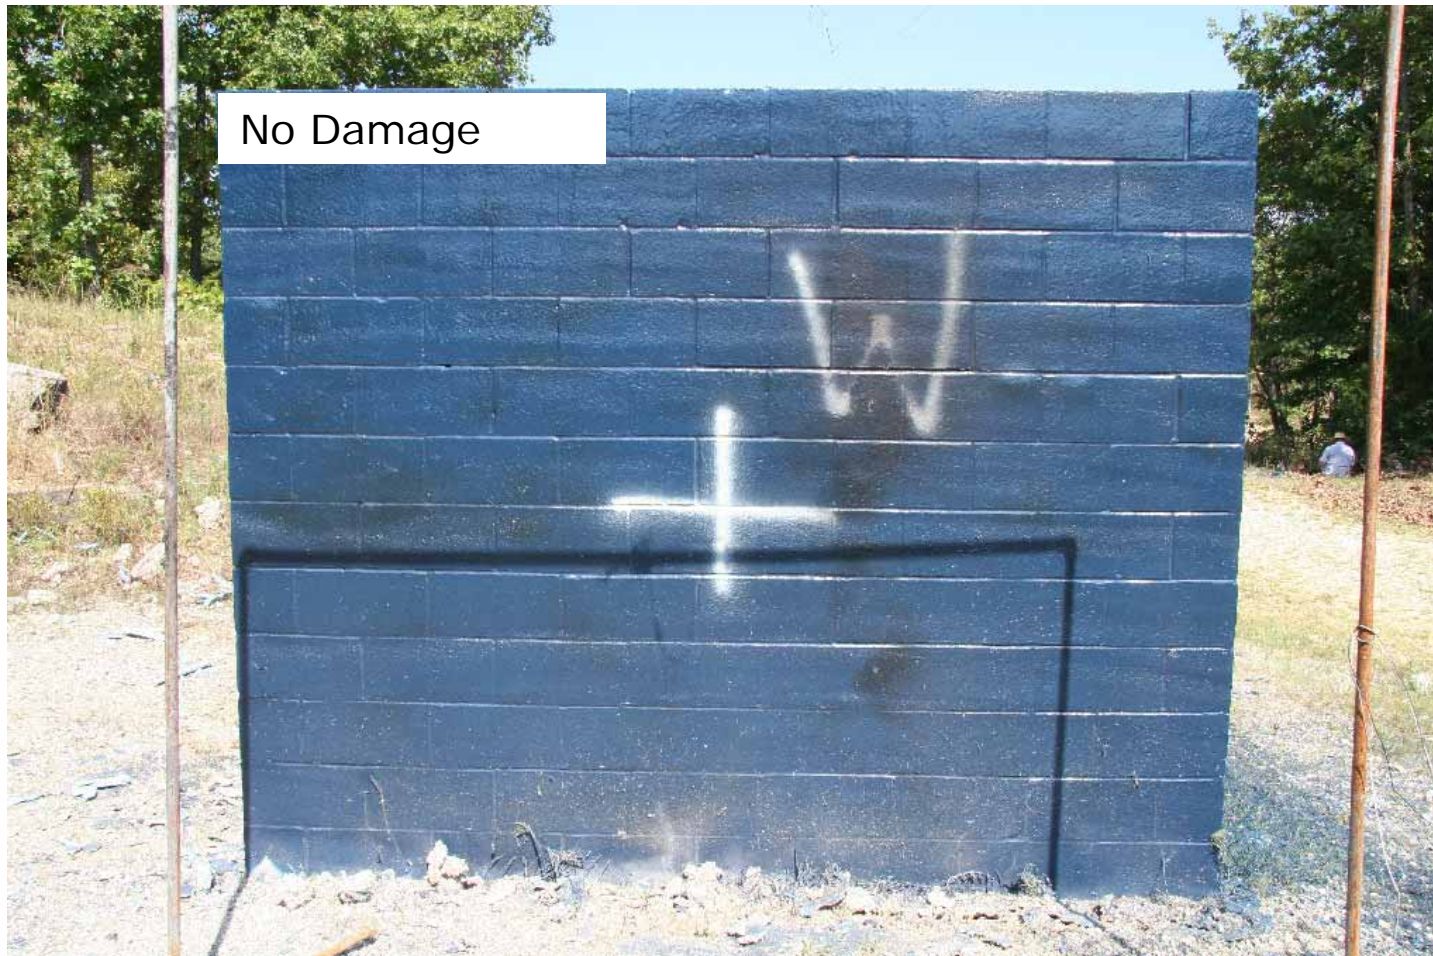
One Side ArmorBlast™ 1/8" Coating Post-Blast: Outside View

In the next two explosions, the ArmorBlast coating on outside without primer (West) and the East wall with primer showed nearly identical results. There was no visible damage to the outside face. Small vertical tension cracks formed on center of the back side. There was no movement of the wall due to deflection.

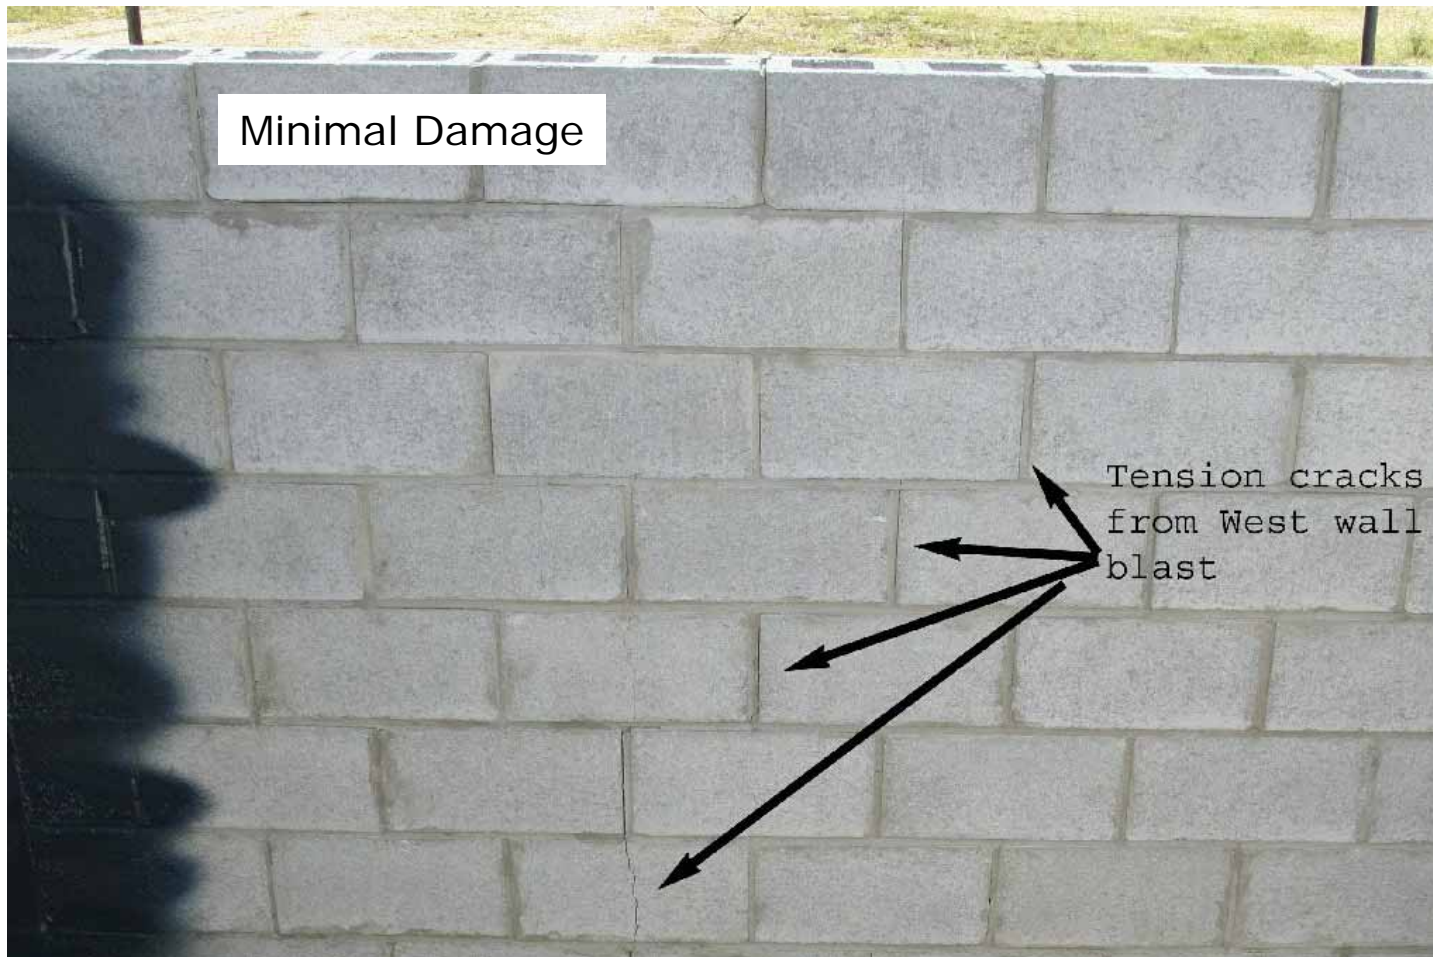
One Side ArmorBlast™

1/8" Coating Post-Blast: Inside View

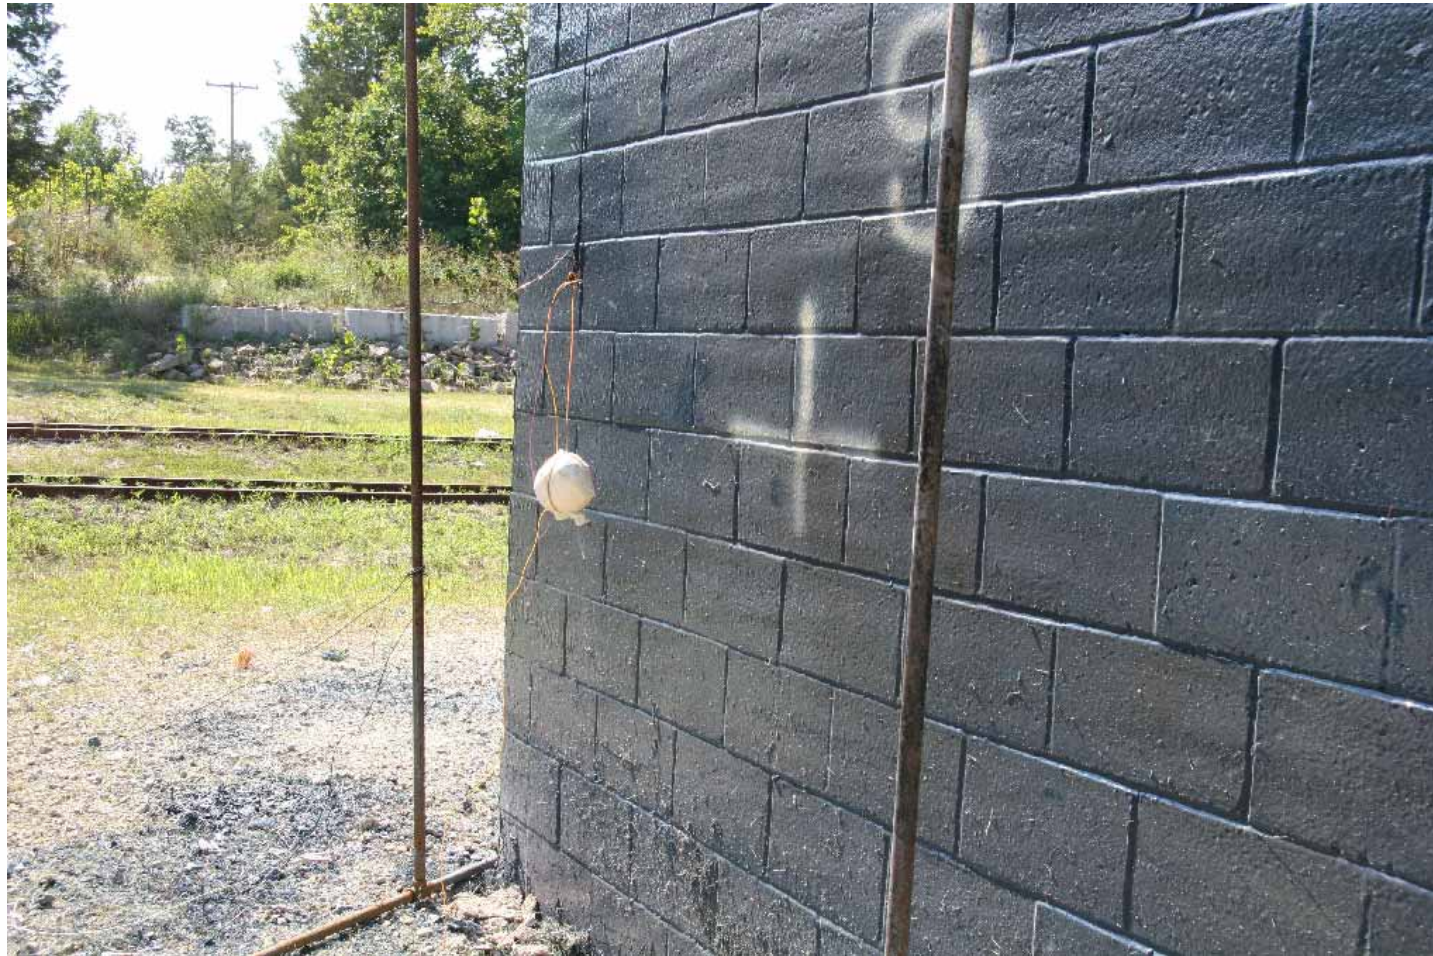
Two Sides ArmorBlast[™]

1/8" Coating Pre-Blast @ 1½ ft: Outside View

The remaining wall (South) had ArmorBlast on the inside and out and no primer. The blast did no visible damage to either side. Because of this, researchers decided to continue blasting to determine the point of wall failure.

The next blast was set on the South wall with a two-pound C-4 charge at 18 inches distance rather than 36 inches. There was still no visible damage.

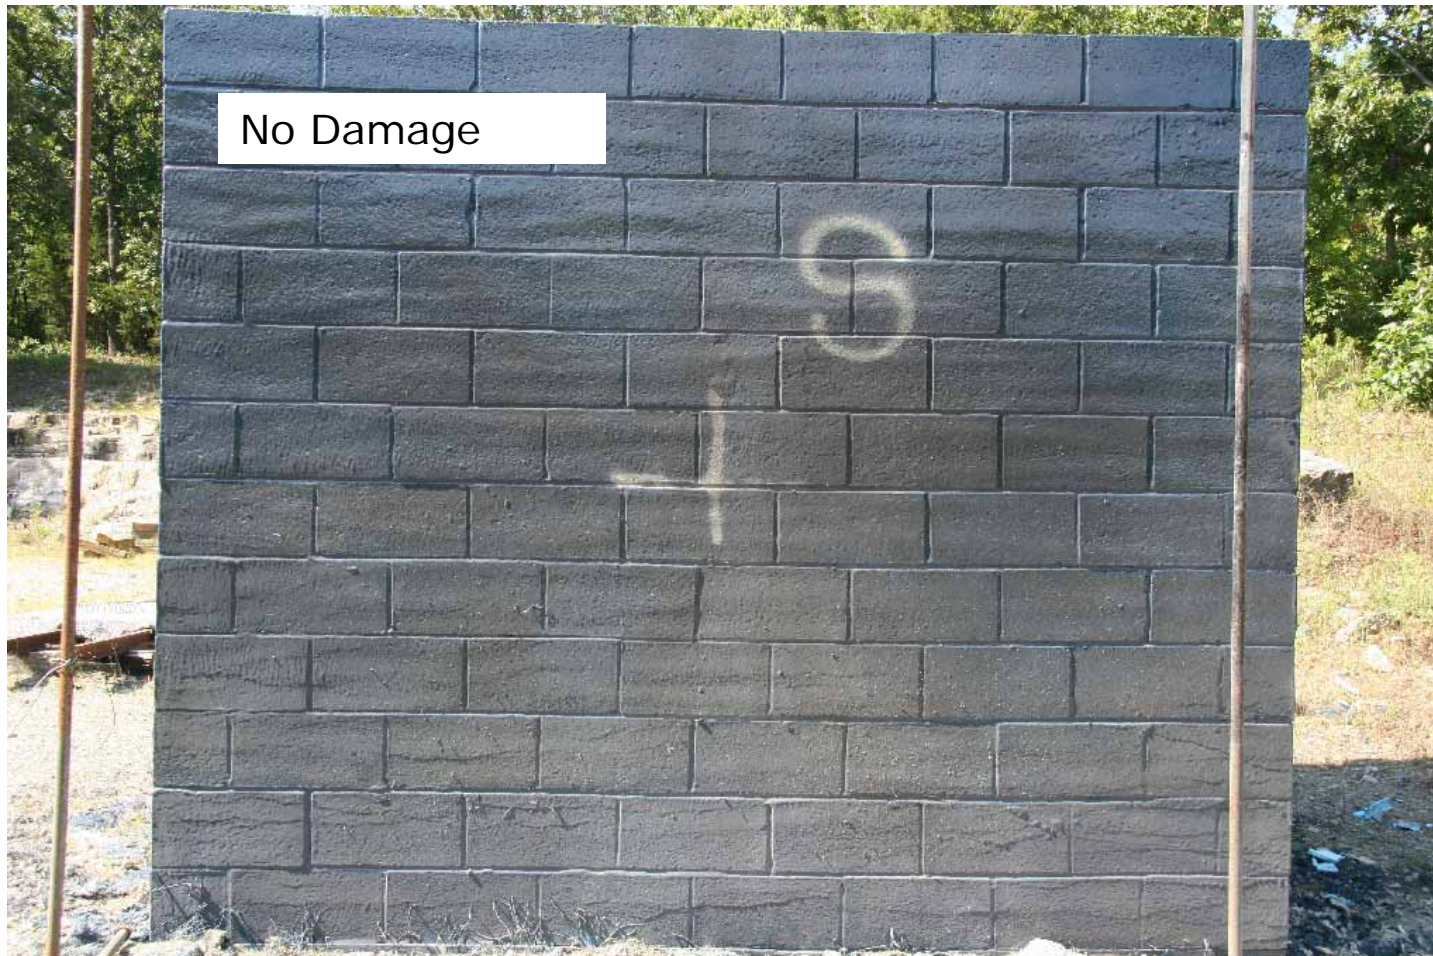
Two Sides ArmorBlast™

1/8" Coating Post-Blast @ 1½ ft: Outside View

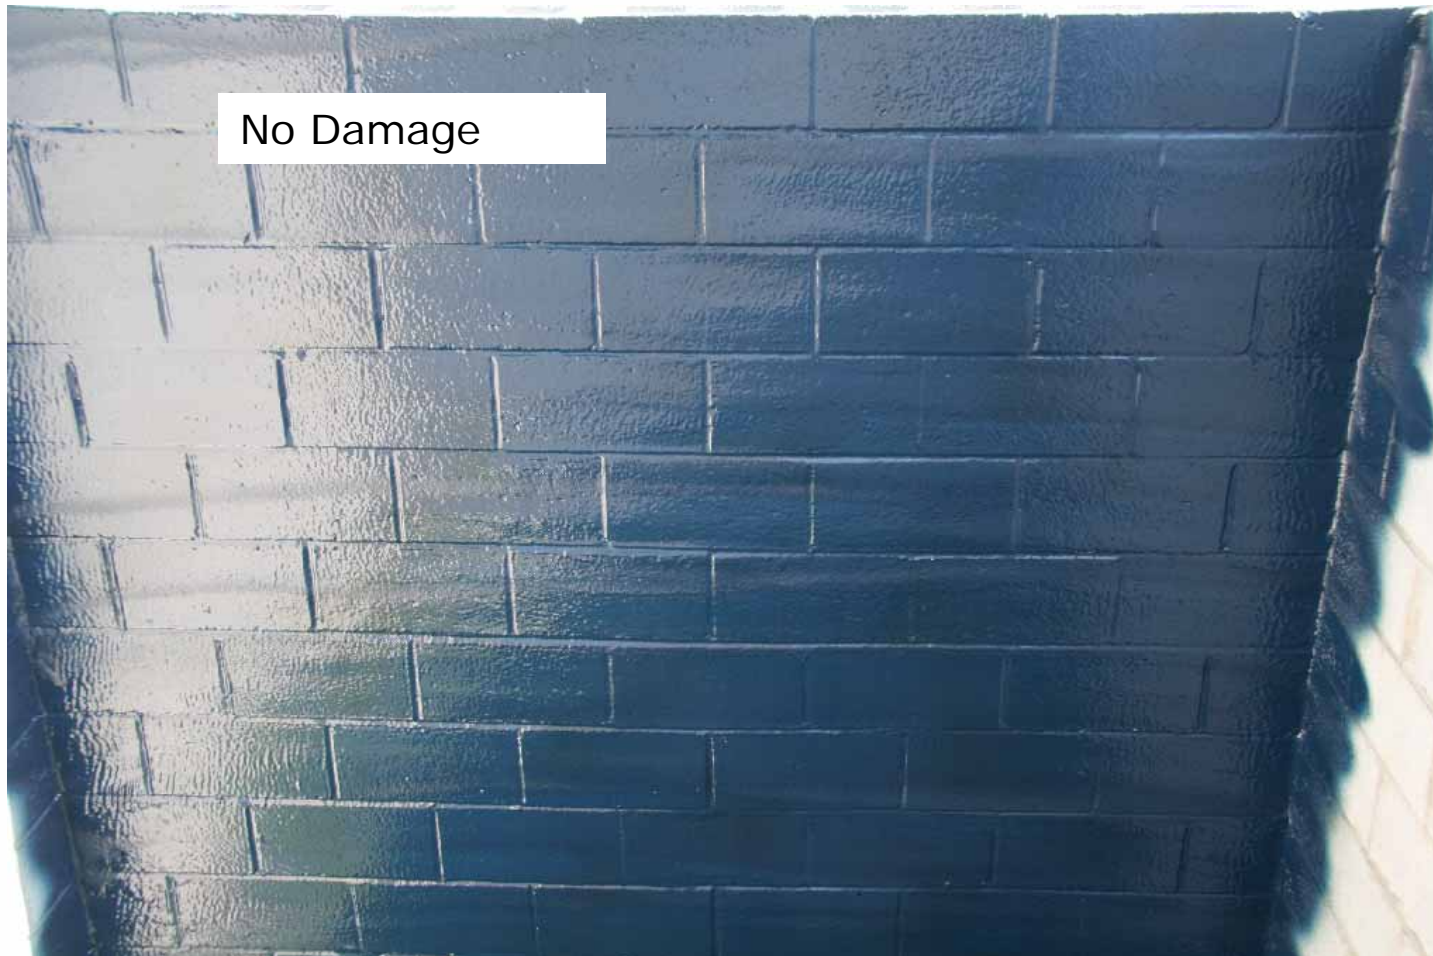
ArmorBlast™

1/8" Coated Two Sides Post-Blast @ 1½ ft: Inside View
