# ArmorThane®

## ArmorBlast™ Coating Withstands Explosion

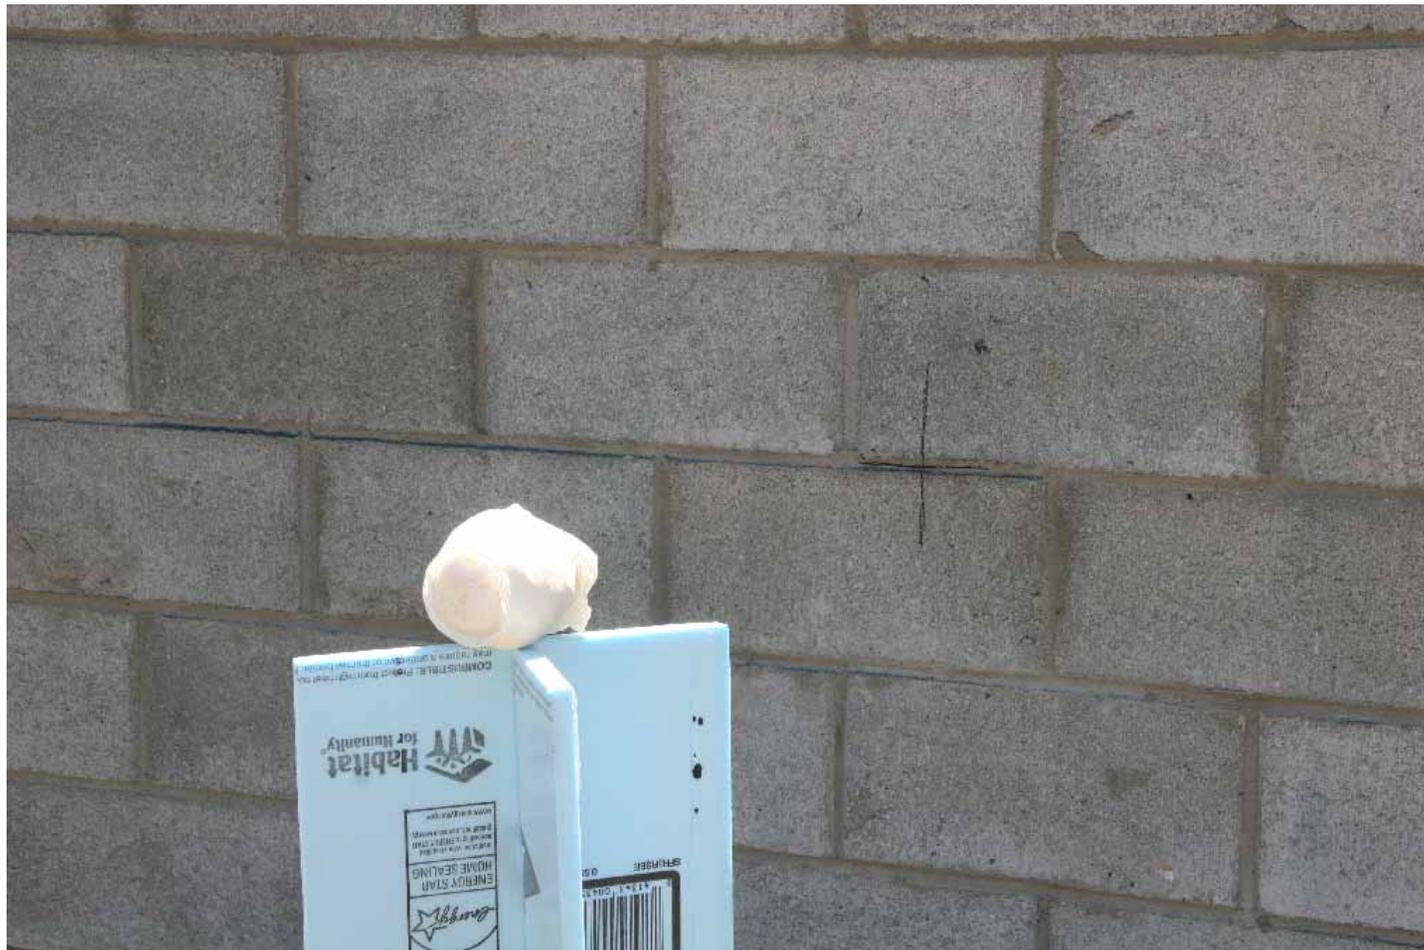
## Uncoated Control Wall

Pre-Blast: Outside View @ 3ft

Each wall was prepared for a different test including an uncoated Control wall (North). Both video and digital still photography documented the events.

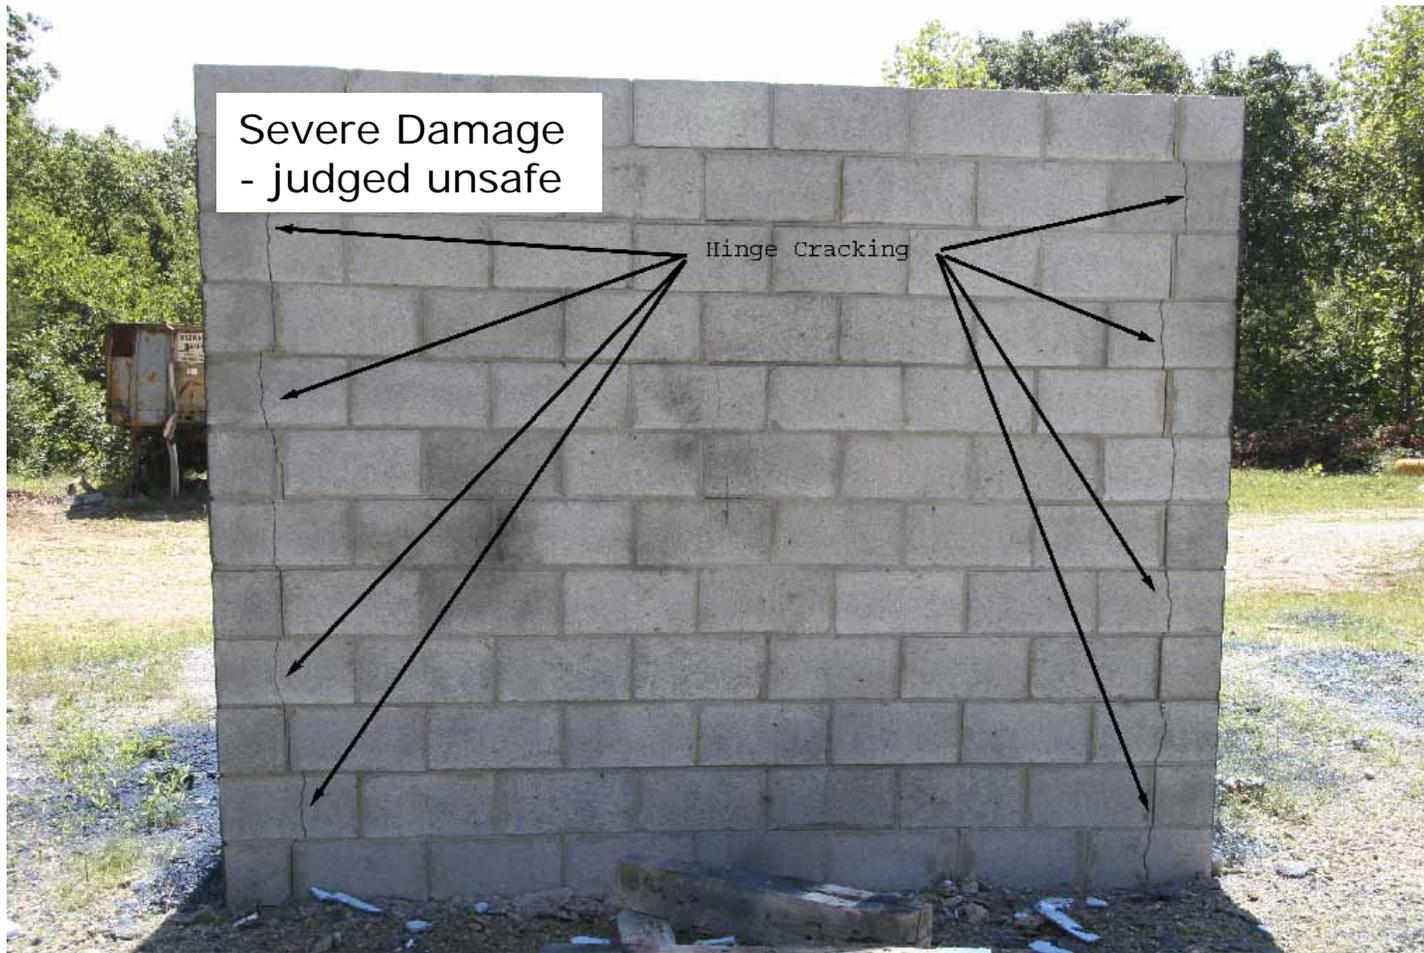
## Uncoated Control Wall Post-Blast Results: Outside View

With the first two-pound charge, the Control wall (North) cracked vertically in the center of the back side opposite the charge position. Small cracks also formed randomly

on the front and vertical hinge cracks were found on either side where the uncoated wall attached to the other walls.

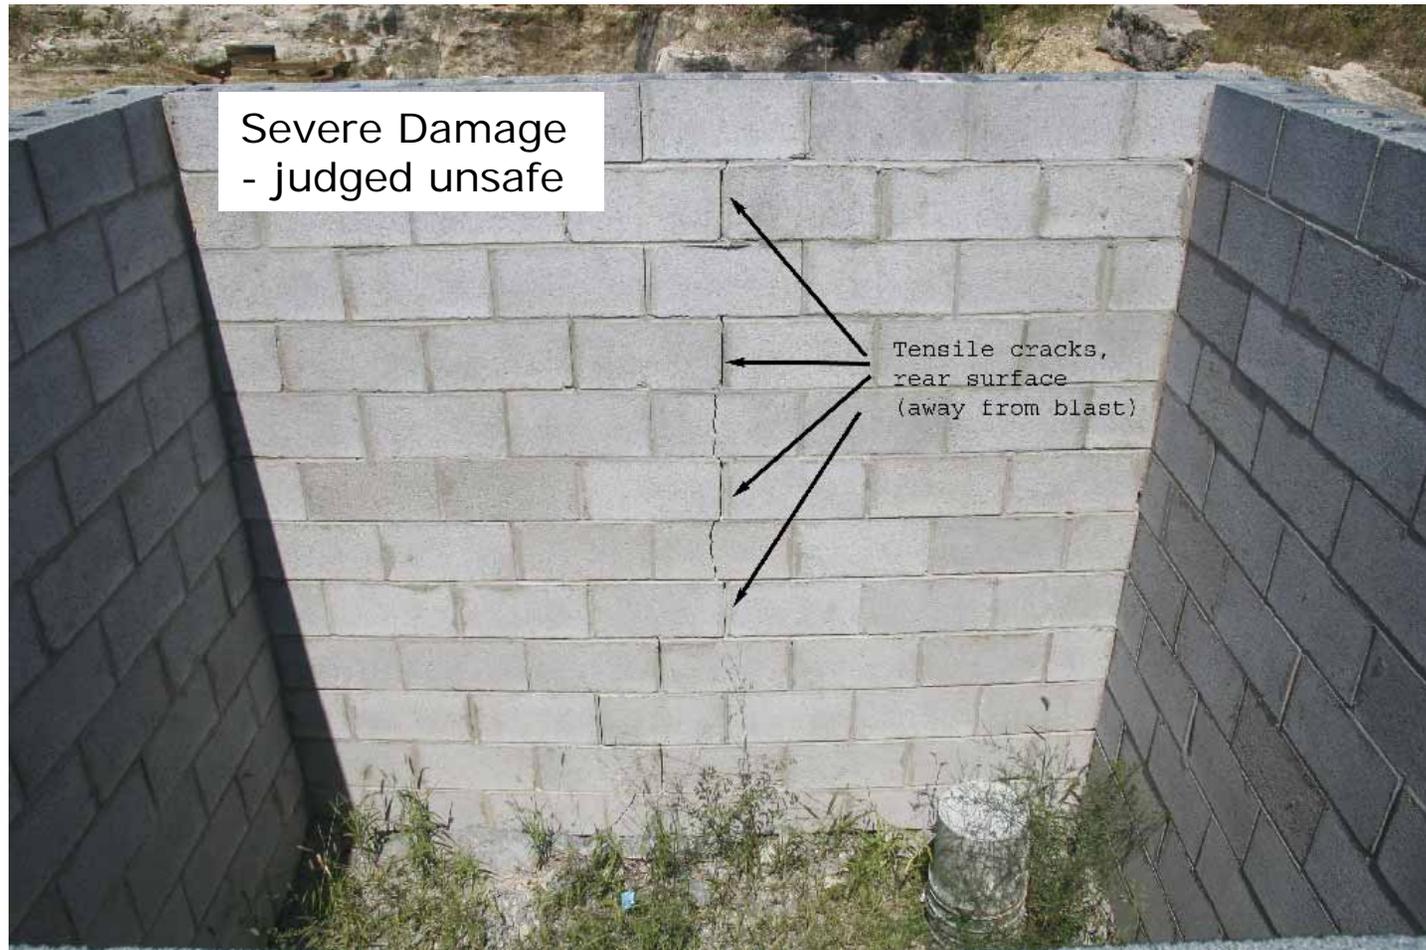
## Uncoated Control Wall

### Post-Blast Results: Inside View

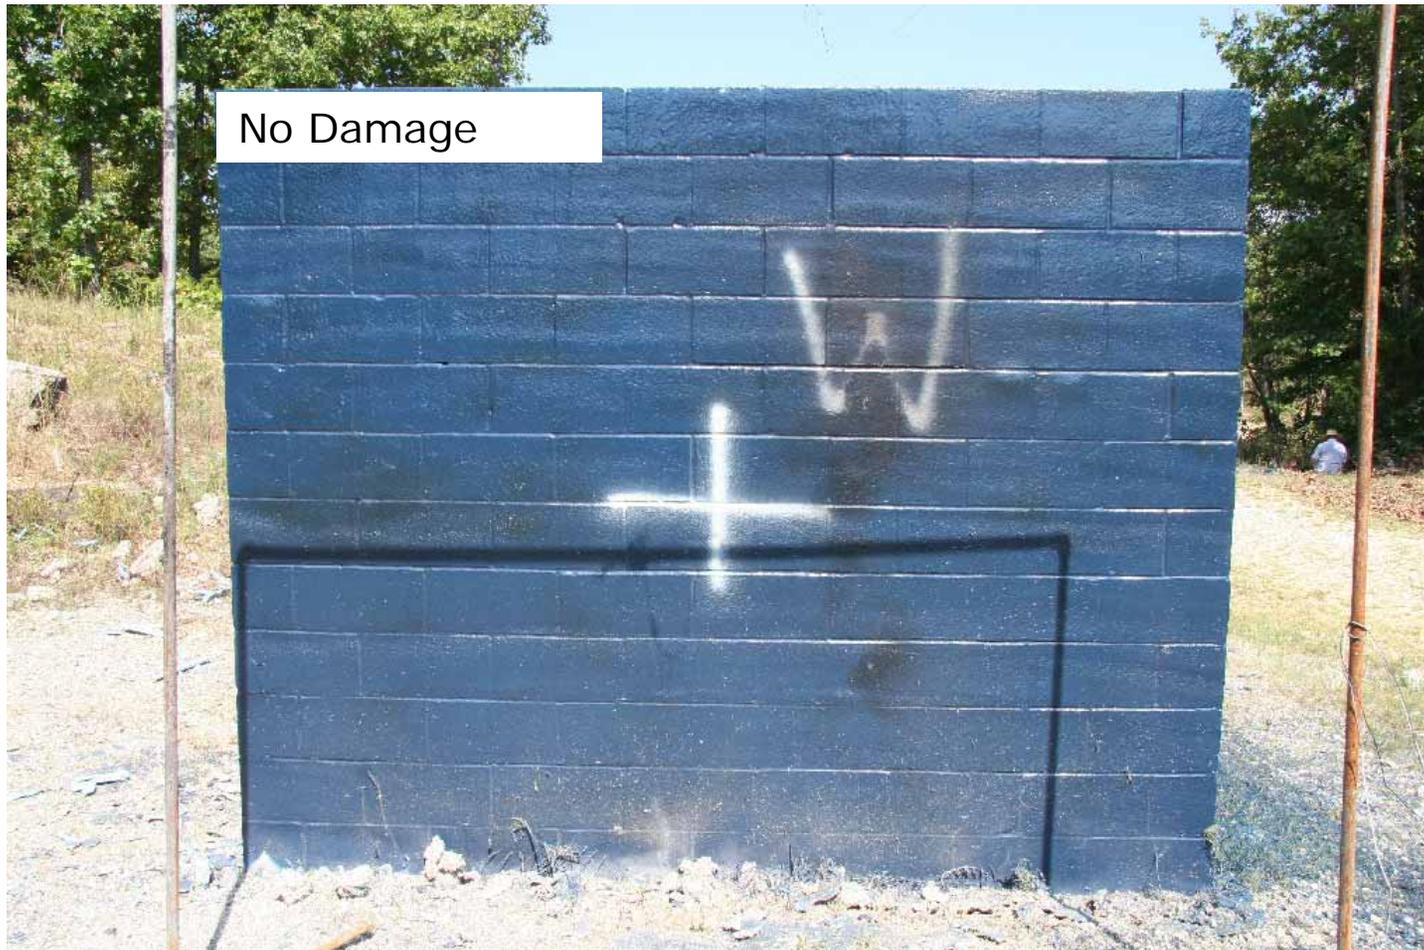
## One Side ArmorBlast™ 1/8" Coating Post-Blast: Outside View

In the next two explosions, the ArmorBlast coating on outside without primer (West) and the East wall with primer showed nearly identical results. There was no visible damage to the outside face. Small vertical tension cracks formed on center of the back side. There was no movement of the wall due to deflection.

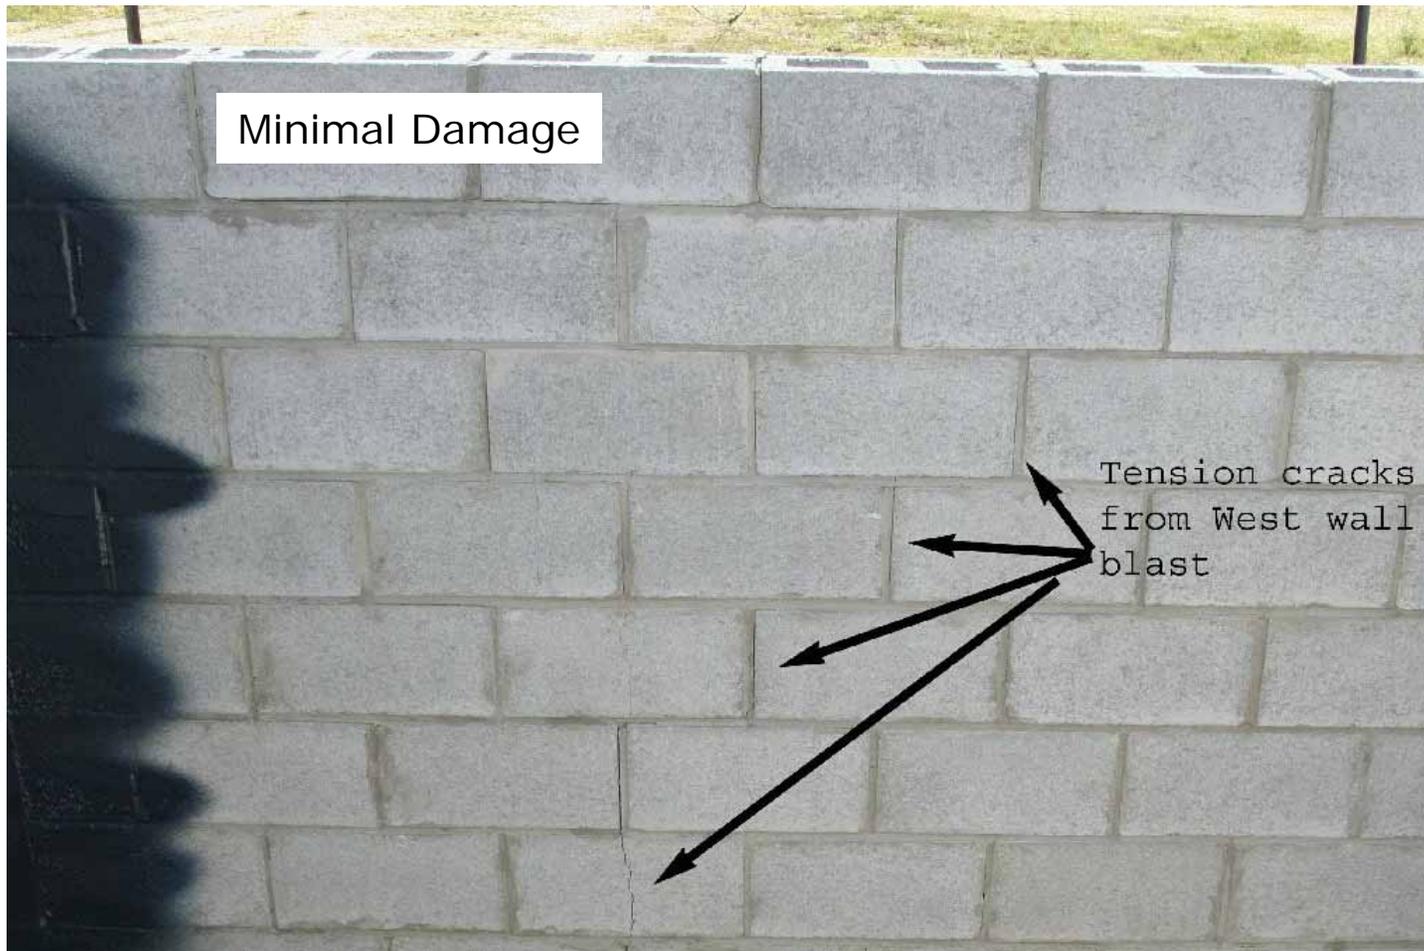
## One Side ArmorBlast™

1/8" Coating Post-Blast: Inside View

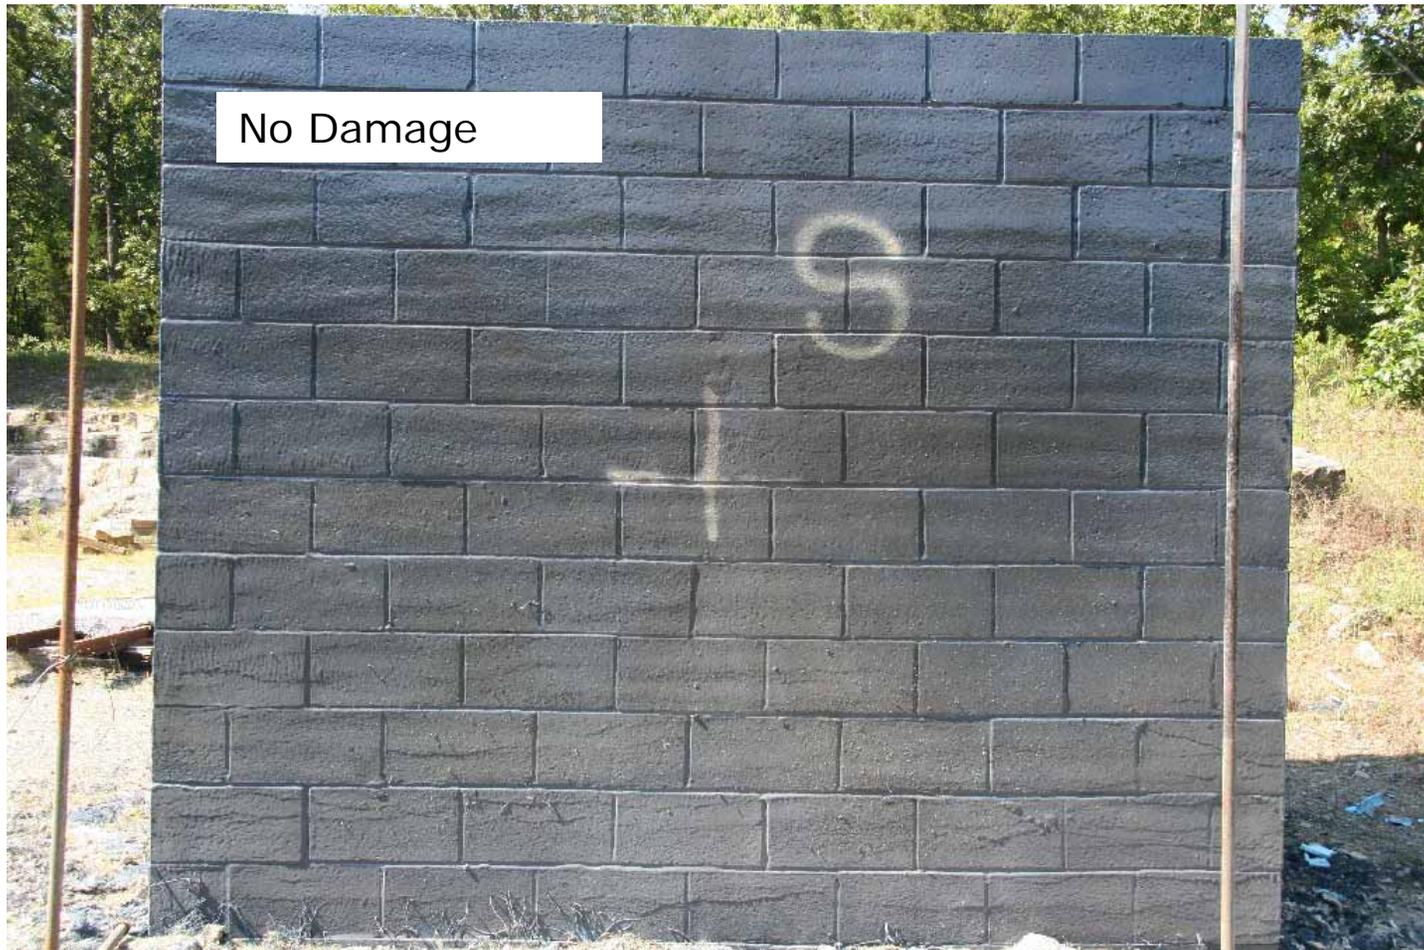
## Two Sides ArmorBlast™

1/8" Coating Post-Blast @ 1½ ft: Outside View

The next blast was set on the South wall with a two-pound C-4 charge at 18 inches distance rather than 36 inches. There was still no visible damage.

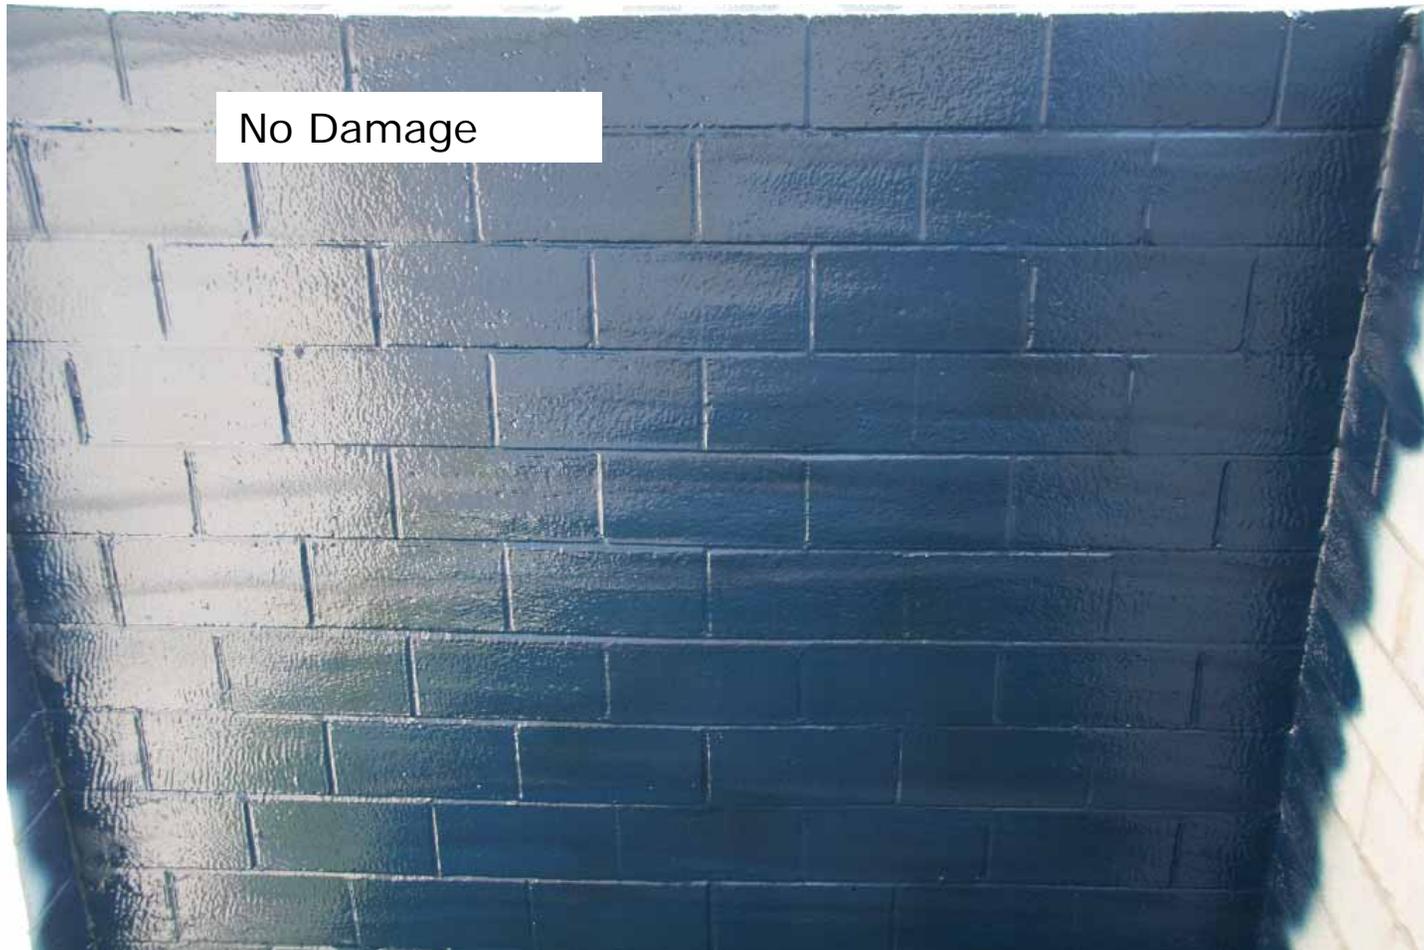
## ArmorBlast™

**1/8" Coated Two Sides Post-Blast @ 1½ ft: Inside View**
